# **Collision Analysis**

# **Working Group (CAWG)**

65 Main-Track Train Collisions, 1997 through 2002:

Review, Analysis, Findings, and Recommendations

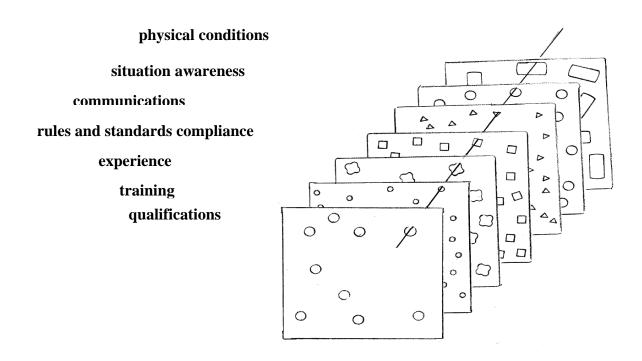
Figure 4-1. Swiss Cheese Model of Collision Causation.

James Reason created the Swiss Cheese Model<sup>24</sup> to demonstrate the multiple defenses (barriers, rules, procedures, systems, training, communications) set up to prevent human-factor accidents like the 65 main-track train collisions. A representation of his model is shown in Figure 4-1. Only when a "straight shot" is created to the target through all the barriers does a human-factors collision occur.

The Swiss Cheese Model helps in demonstrating myths about collisions. First, collisions usually involve several factors. Rarely are collisions the result of a single cause. CAWG has carried over from its work in Switching Operations Fatality Analysis (SOFA) the concept of a sequence of events leading up to, in its case, a switching fatality, which often involves human-factor issues. To describe the switching-fatality process, SOFA used the same Possible Contributing Factors (PCFs) approach that CAWG is using to analyze the 65 main-track train collisions. SOFA rejected the more restrictive, and less amenable to prevention, idea of a single *cause*. SOFA demonstrated the use of PCFs can empower the railroad industry to identify and address specific issues where risks and exposures can be further reduced.
